National Transportation Safety Board

Aircraft Accident Investigative Update

On January 26, 2020, at 0945 Pacific standard time (PST), a Sikorsky SK76B helicopter, N72EX, collided with hilly terrain near the city of Calabasas, California. The pilot and eight passengers were fatally injured, and the helicopter was destroyed by impact forces and fire. The helicopter was operated by Island Express Helicopters Inc. under Title 14 Code of Federal Regulations (CFR) Part 135 as an on-demand passenger visual flight rules (VFR) flight from John Wayne-Orange County Airport, (KSNA), Santa Ana, California, to Camarillo Airport, (KCMA), Camarillo, California.

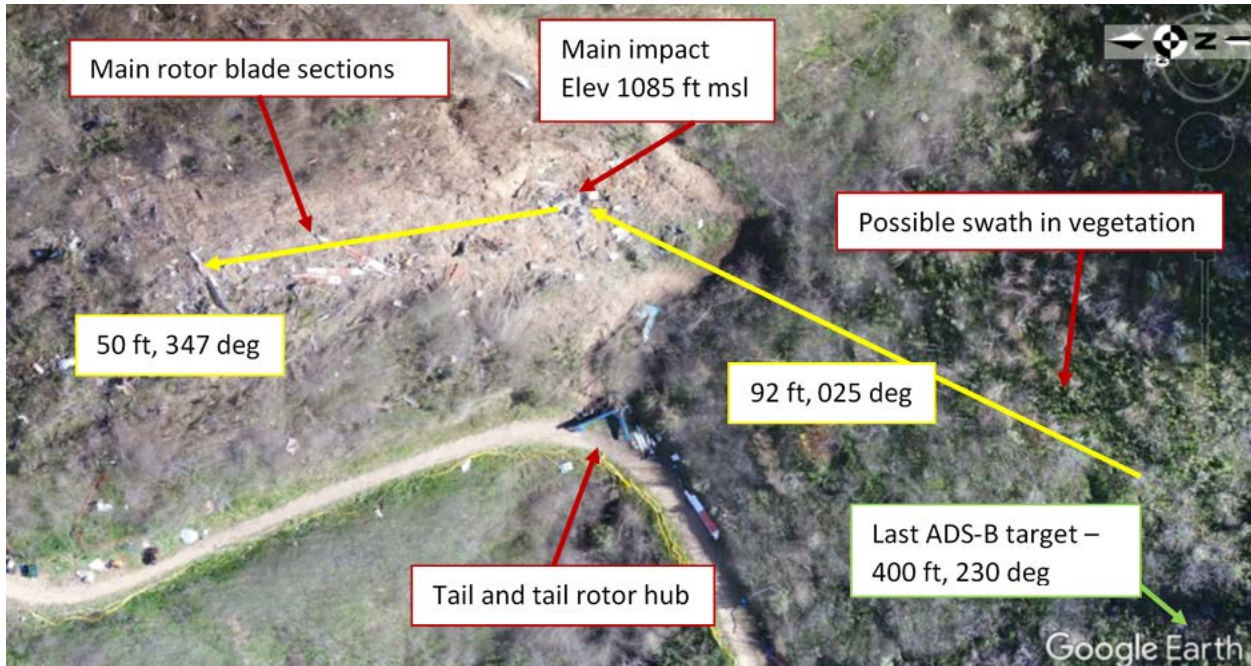
Figure 1a. Google Earth map of wreckage area – southern (directions reference true north)

All significant components of the helicopter were located within the wreckage area. Examination of the main and tail rotor assemblies found damage consistent with powered rotation at the time of impact. The initial point of impact consisted of highly fragmented cabin and cockpit debris. The vertical pylon and horizontal stabilizer were located about 40 feet below (downhill from) the

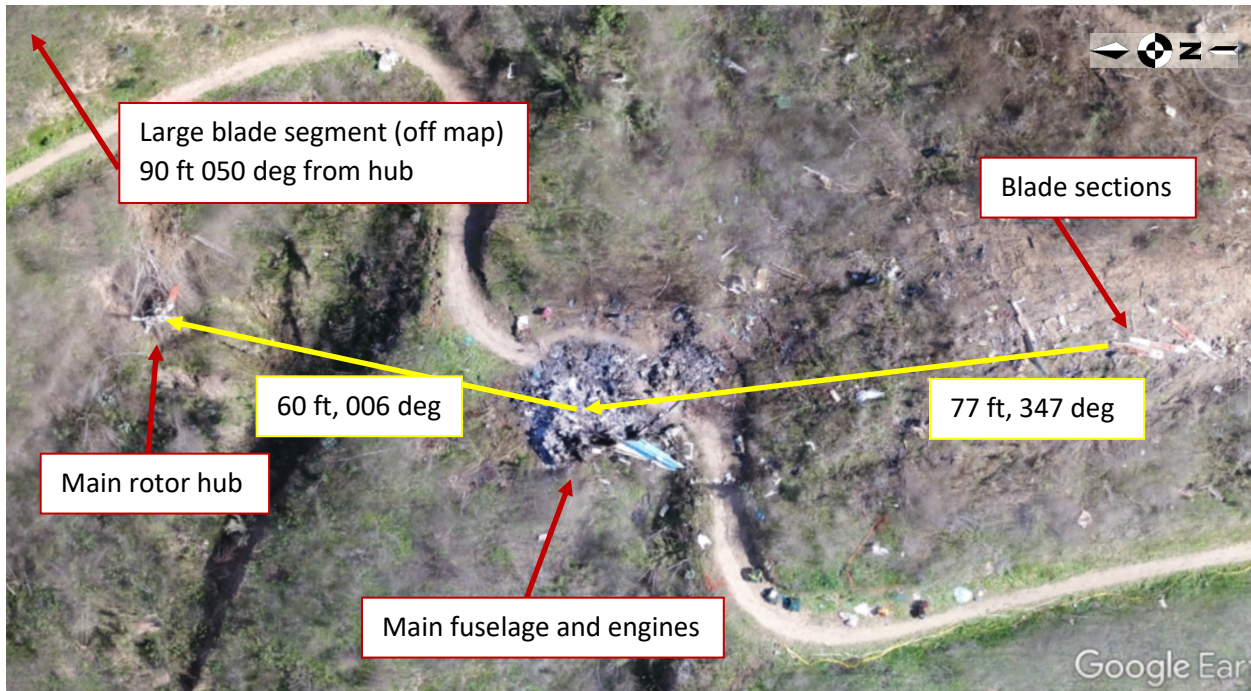
Figure 1b. Google Earth map of wreckage area – northern

The main wreckage was about 127 feet from the impact crater along a 347° true bearing (335° magnetic) and consisted of the empennage/tailboom, both engines, avionics boxes, and portions of the cockpit instrument panel. The entire fuselage/cabin and both engines were subjected to a postcrash fire. The cockpit was highly fragmented. The instrument panel was destroyed and most instruments were displaced from their panel mounts. Flight controls were fragmented and fire damaged.

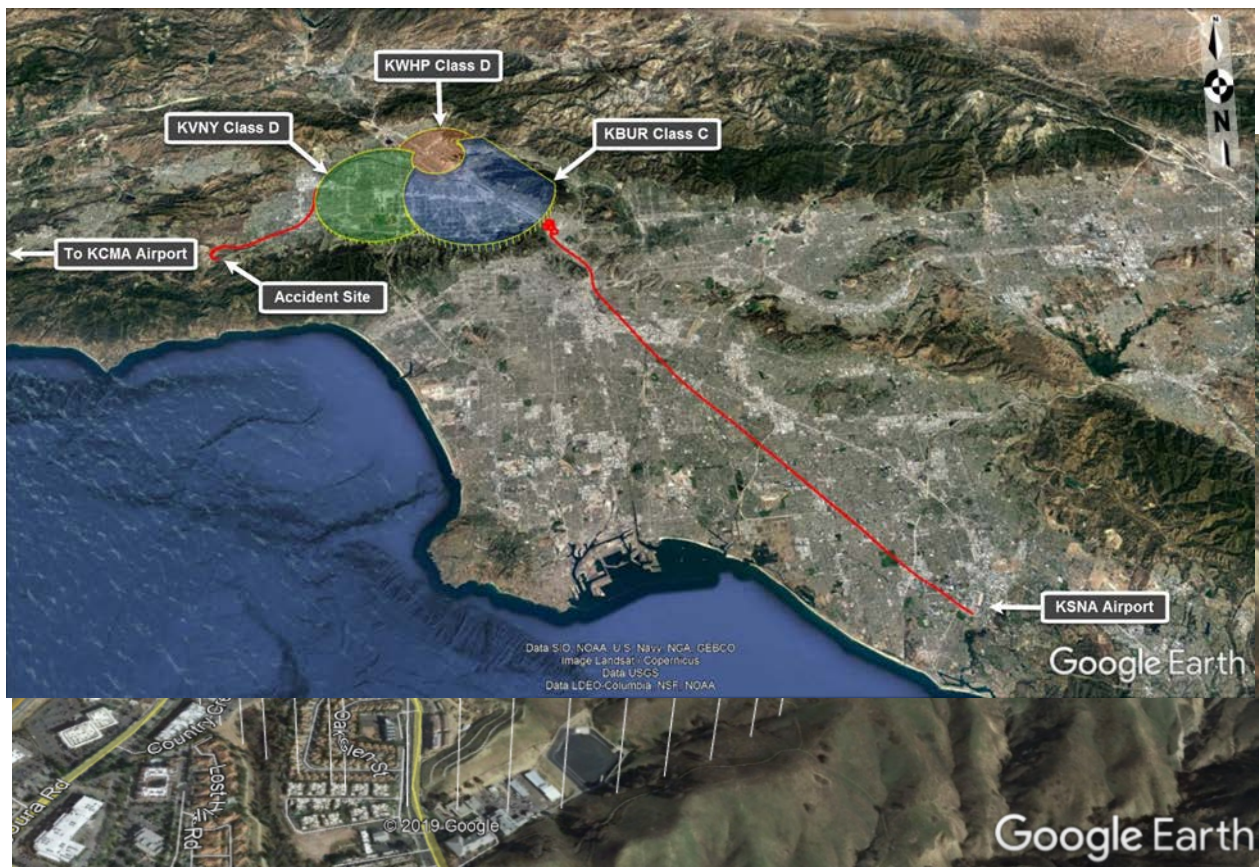
Radar/ADS-B data indicate the aircraft was climbing along a course aligned with Highway 101 just east of the Las Virgenes exit. Between Las Virgenes and Lost Hills Road, the aircraft reached 2,300 feet msl (approximately 1,500 feet above the highway, which lies below the surrounding terrain) and began a left turn. Eight seconds later, the aircraft began descending and the left turn continued. The descent rate increased to over 4,000 feet per minute (fpm), ground speed reached 160 knots. The last ADS-B target was received at 1,200 feet msl approximately 400 feet southwest of the accident site.

Figure 2. Overall Radar/ADS-B track of N72EX

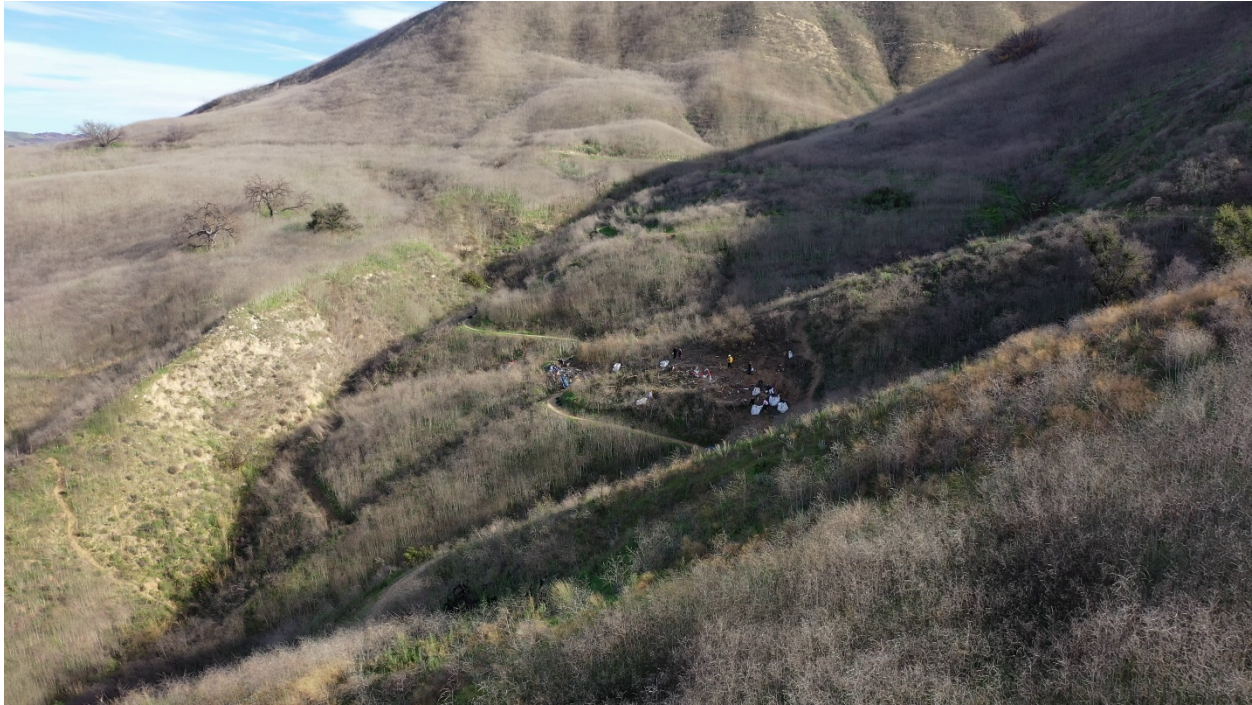
Figure 3C. Still image from drone video duplicating the flightpath of N72EX at position/altitude of last ADS-B target

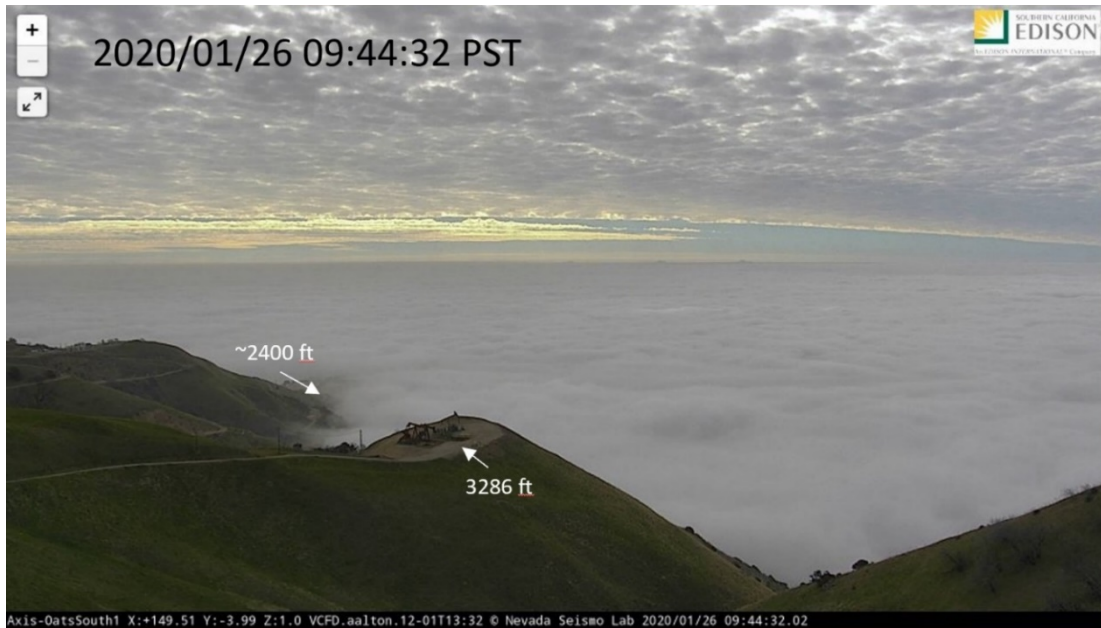
An ALERTWildfire camera image (figure 4) taken at 0944 PST looking southeast toward the city of Van Nuys, as publicized on the National Weather Service (NWS) Los Angeles Twitter account, depicted the top of the cloud layer to the east of the accident site. The NWS analyzed the top of the cloud layer to be about 2,400 feet above mean sea level near the terrain in the foreground of the image.

Figure 4. Camera image from 0944 PST

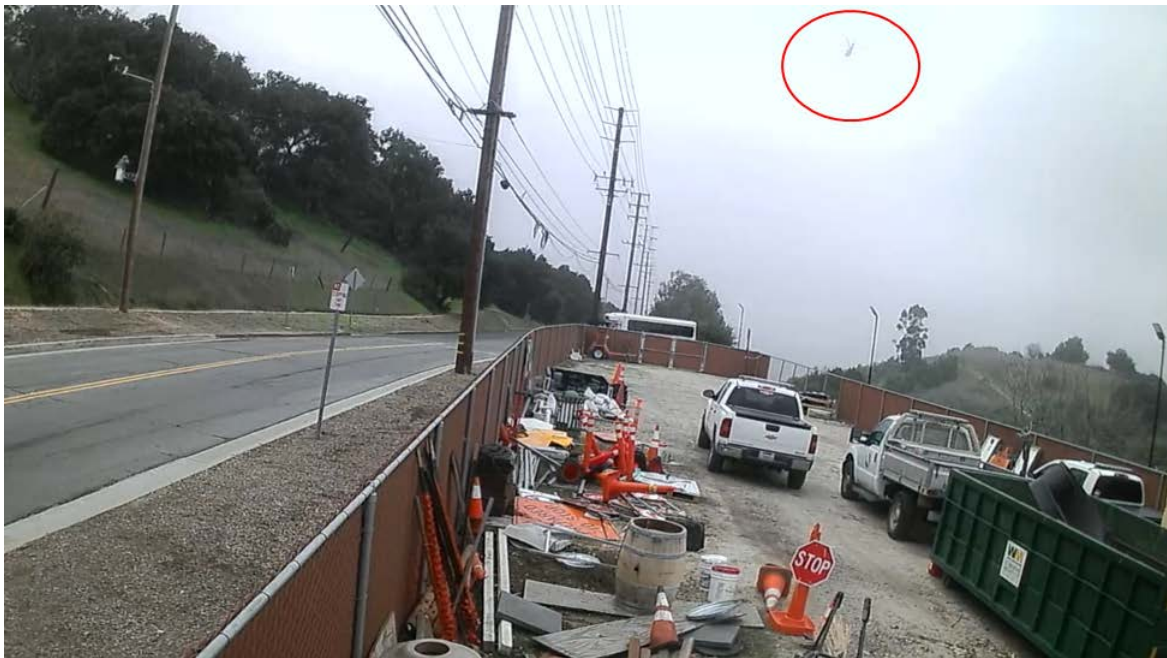
Figure 6 is a still frame from a security video obtained from a road maintenance yard adjacent to Moreau Road and Highway 101 depicting the helicopter proceeding westward along the highway and disappearing into the clouds.

Figure 6. Still frame from security video showing N72EX flying into clouds (circled in red)
