STATE OF CALIFORNIA
DEPARTMENT OF CALIFORNIA HIGHWAY PATROL
TRAFFIC COLLISION REPORT
CHP 555 Page 1 (Rev. 6-17) OPI 060

DATE OF COLLISION (MO. DAY YEAR) 02-23-2021	TIME (2400) 0710	NCIC # 1900	OFFICER I.D. 634431	NUMBER 921-00603-1720-471
--	---------------------	----------------	------------------------	------------------------------

PROPERTY DAMAGE	OWNER'S NAME City of Rolling Hills Estates	OWNER'S ADDRESS [REDACTED]	NOTIFIED <input checked="" type="checkbox"/> YES <input type="checkbox"/> NO
	DESCRIPTION OF DAMAGE City of Rolling Hills Estates sign knocked down/broken into multiple pieces.

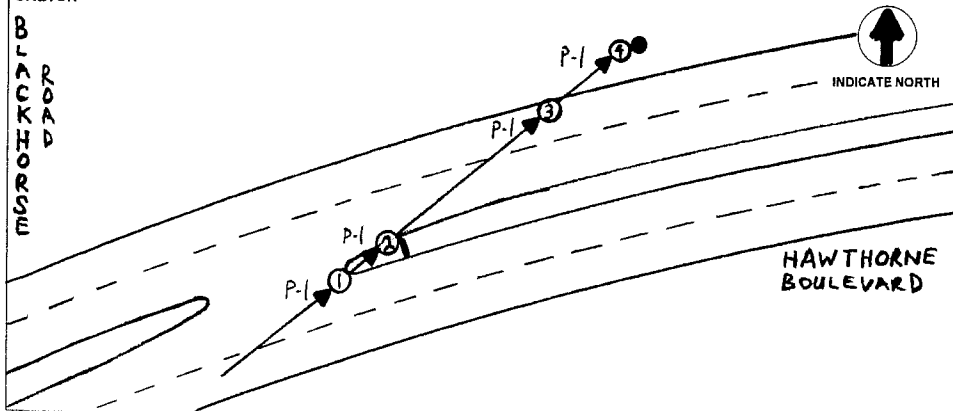
SKETCH

1. 1.) AREA OF IMPACT (AOI):					
2. AOI #1: 32 feet west of the east curb line of Hawthorne Boulevard. (P-1/Vehicle vs. median)					
3. 2360 feet north of the north curb line of Blackhorse Road.

4. AOI #2: 40 feet west of the east curb line of Hawthorne Boulevard. (P-1/Vehicle vs. R.H.E. sign)					
5. 2409 feet north of the north curb line of Blackhorse Road.

6. AOI #3: 0 feet west of the west curb line of Hawthorne Boulevard. (P-1/Vehicle vs. west curb)					
7. 2588 feet north of the north curb line of Blackhorse Road.

8. AOI #4: 20 feet west of the west curb line of Hawthorne Boulevard. (P-1/Vehicle vs. tree)					
9. 2659 feet north of the north curb line of Blackhorse Road.

10.					
11. C. PHYSICAL EVIDENCE:					
12. 1.) SKID MARKS: I did not observe any skid marks.					
13.					
14. 2.) DEBRIS:					
15. See factual diagram.
